Mike Hadley sent an interesting article on work proposals for this building on the Welsh Highland

Observant readers may have noticed that Betws Garmon Station has recently acquired vegetation on the top of its remaining walls. Not so long ago any half diligent building manager would have got the lot cleared off pronto but ideas come full circle and putting turf on the top of stone walls is now seen as a means of preserving them rather than a threat to them.

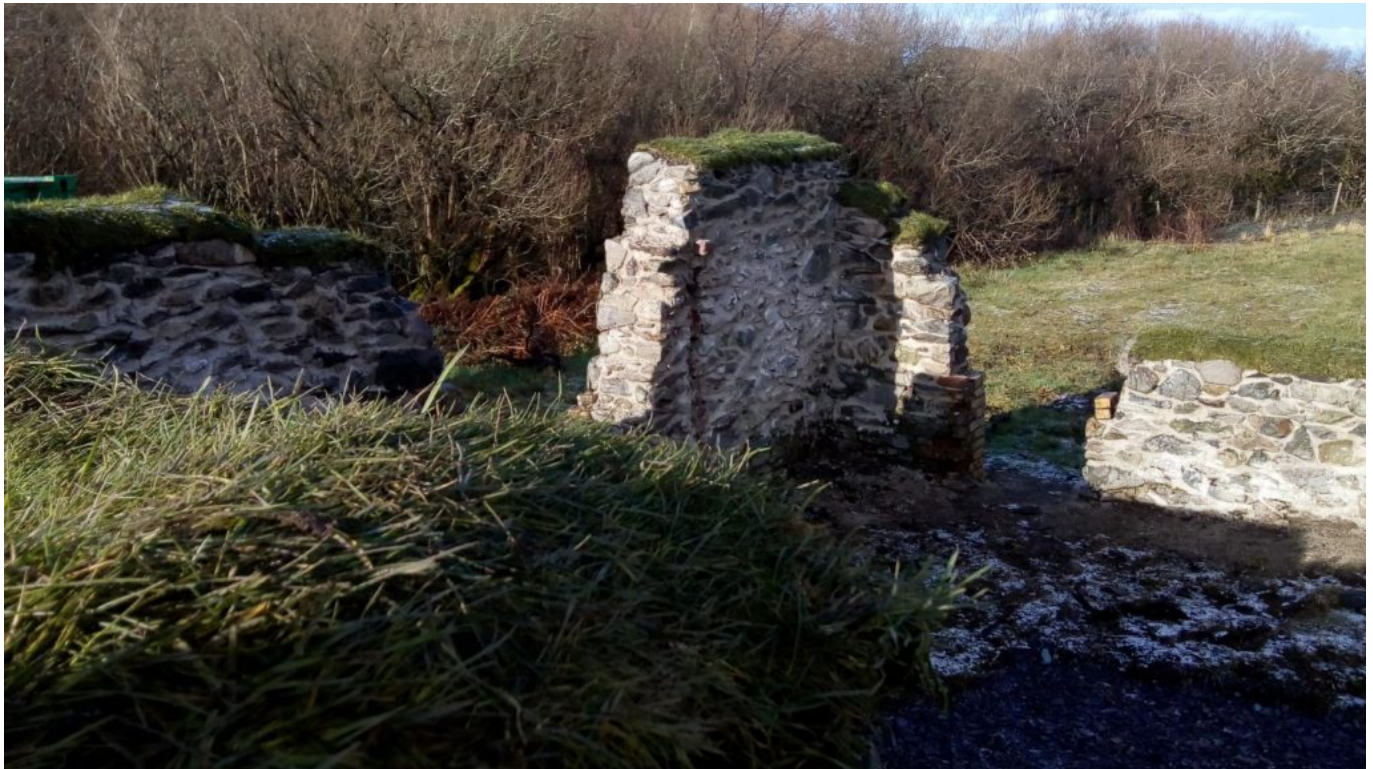
The station is one of the original NWNNG Railways structures with a slated roof and random stone walls (mostly 500mm thick) and brick quoins and window and door reveals.

It's part of a conservation scheme instigated by the Welsh Highland Railway Heritage Group and involved raking out and repointing the mortar joints to the stonework, replacing some stonework where stones were lying adjacent, filling the inside with slate waste to just below the former floor level andputting earth and turf on top of the walls (now legitimised by the title 'soft capping'). Lime mortar was used to bed the stonework in.
